**State of Louisiana
Office of Coastal Protection and
Restoration**

2011 Annual Inspection Report

**GIWW/ CLOVELLY HYDROLOGIC
RESTORATION**

State Project Number BA-02
Priority Project List 1

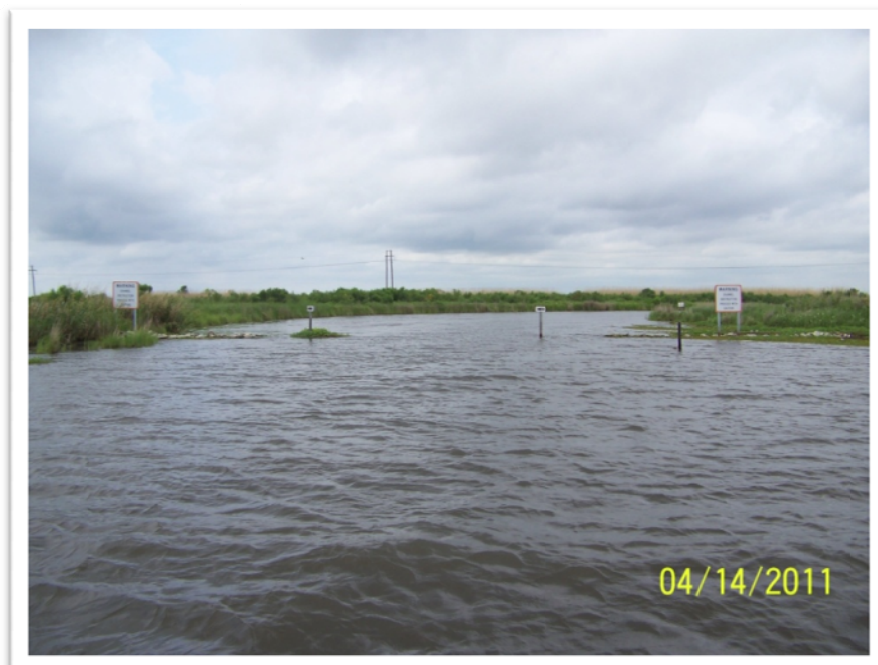
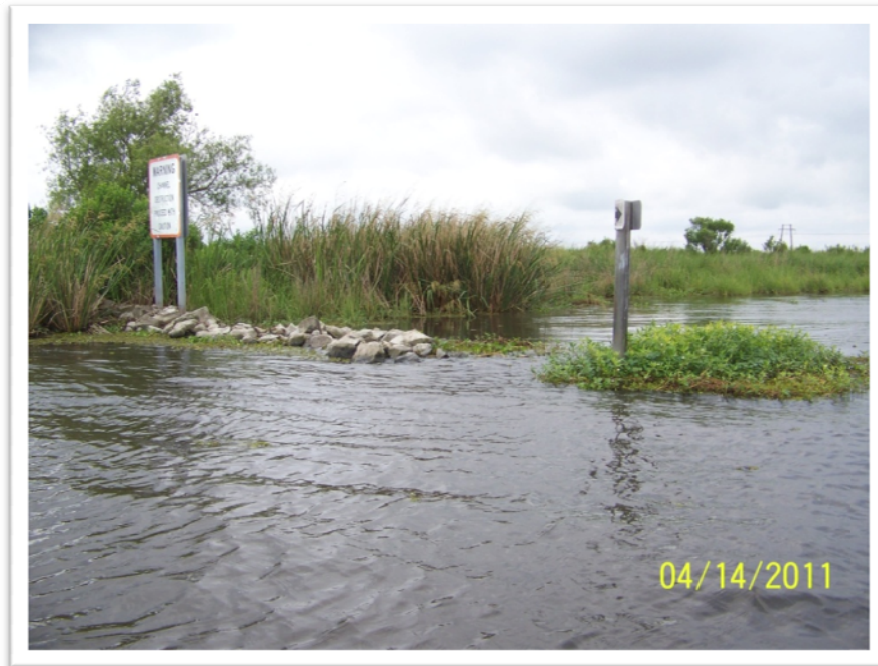
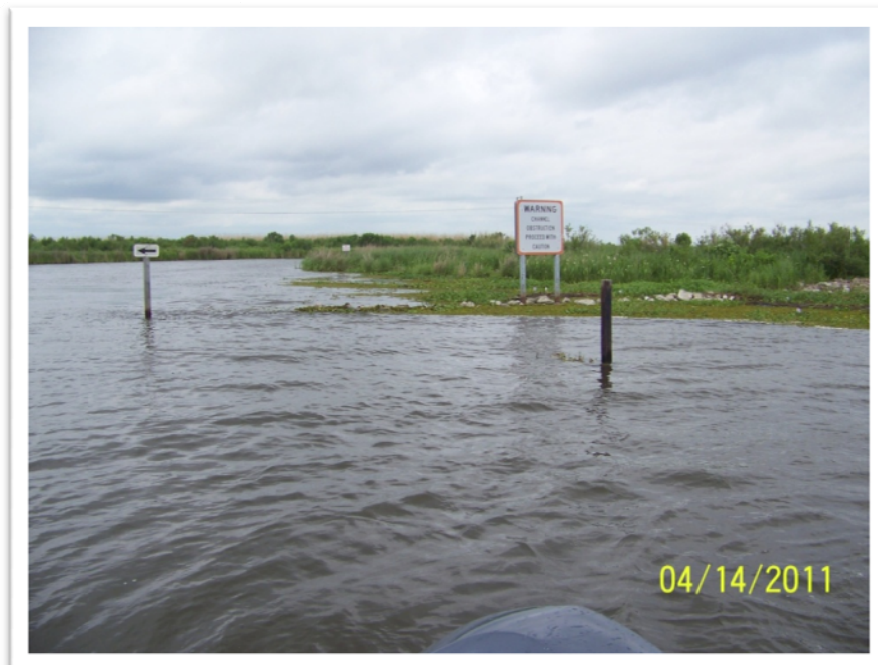
Structure 7 looked to be in fair condition with some settlement of the rock riprap material but no visual damage to the weir or erosion around the bank tie-ins. The as-built drawings show the weir was constructed to a height of -4.4 NAVD in the boat bay and +2.4' NAVD on the north and south sides between the bank and boat bay. The water depth in the boat bay was recorded as 6.2' at the time of the inspection. These observations and supporting data from previous surveys show this structure has settled uniformly along the entire length of the structure approximately 1.0' to 1.5'. Since the settlement of Structure 7 is uniform and relatively minor, we are not recommending corrective actions at this time, but the structure will continue to be monitored during future inspections. All other signs and supports appear to be in good condition. (Appendix B, Photos No.32 through No.34)

Photo 32: Structure 7 fixed crest rock weir with boat bay, looking west

Photo 33: Structure 7 fixed crest rock weir south tie-in to bank, looking south

Photo 34: Structure 7 fixed crest rock weir north tie-in to bank, looking west

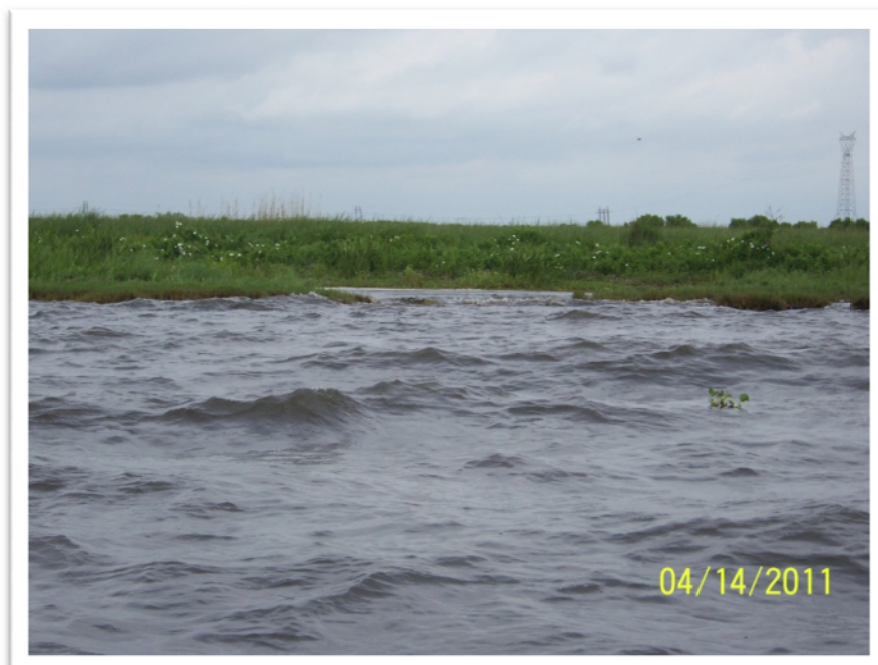
The shoreline from Structure 7 to 14 was visually inspected to observe condition of breaches (see Appendix B, photo 36). There are five (5) breaches identified for repairs and/or refurbishment to be included in the upcoming 2010 Maintenance Project. Breach 1 is located along the north bank of Breton Canal just southwest of the first location canal from Bay L' Ours and is approximately 20' wide. Breach 2 is located along the northeast bank of the second location canal north of Breton Canal and is approximately 10' wide. Breach 3 is located on the south bank of the same location canal as Breach 2 and is approximately 25' wide. Breach 4 is located on the west bank of a location canal that intersects Superior Canal east of Structure No. 1 and is approximately 30' wide. Another breach, designated as Breach 5, was discovered at the end of a dead end oil field slip south of Breach 4. The recommended method of repair for these breaches is included in the conclusion of this report.

In all, a total of five (5) breaches ranging from 10' to 30' wide were identified within the southern portion of the project area which will be included in the 2010 Maintenance Project. Breach locations are shown in the Work Plan Map of Appendix D. The method of repair for breach closures consist of utilizing in situ material from adjacent channel bottoms to reconstruct the earthen dike. Upon completion of the earthen embankment construction, the surface of the earthen dikes will be seeded to protect against erosion.

Photo 36: Small breach in lake rim located between structures 7 and 14A, looking west

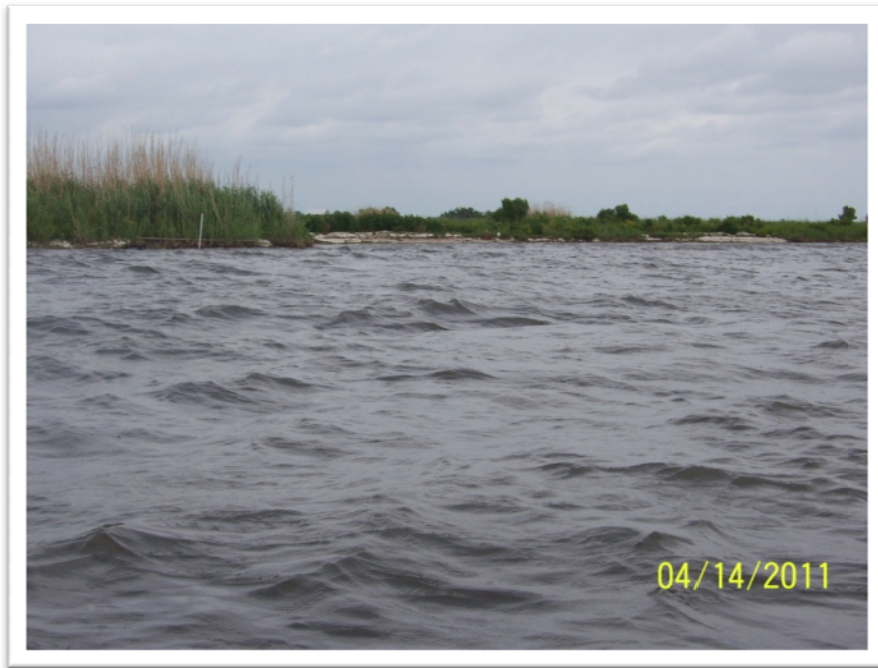
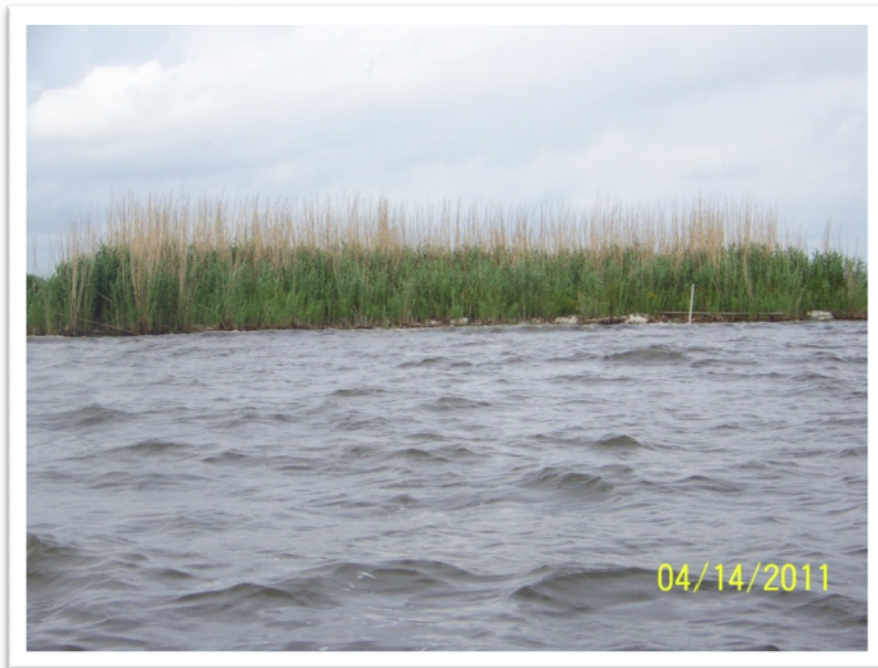
Photo 37: Existing shoreline along the west bank of Little Lake south of Structure 14A, looking west

Photo 38: Existing shoreline along the west bank of Little Lake south of Structure 14A, looking west

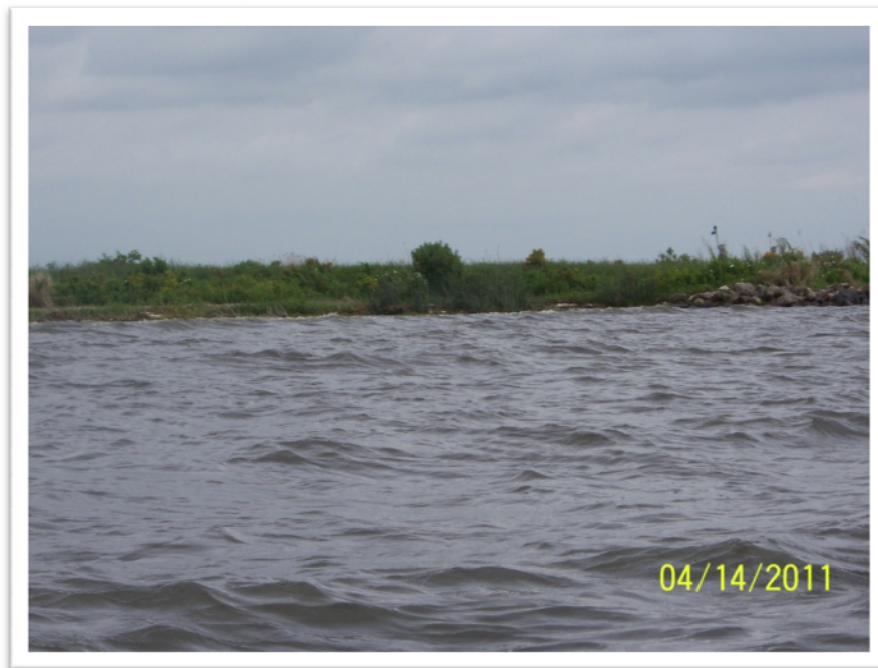
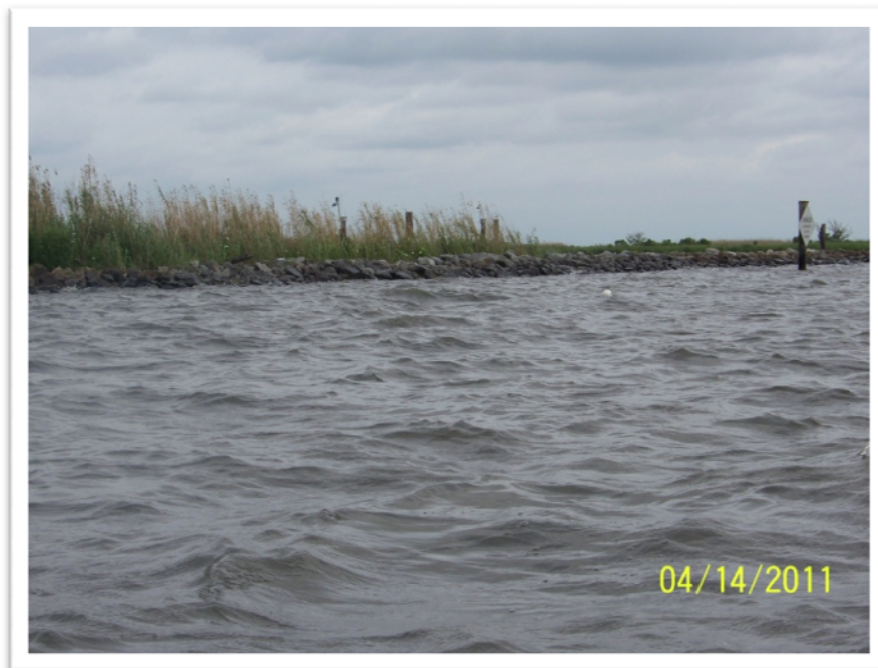
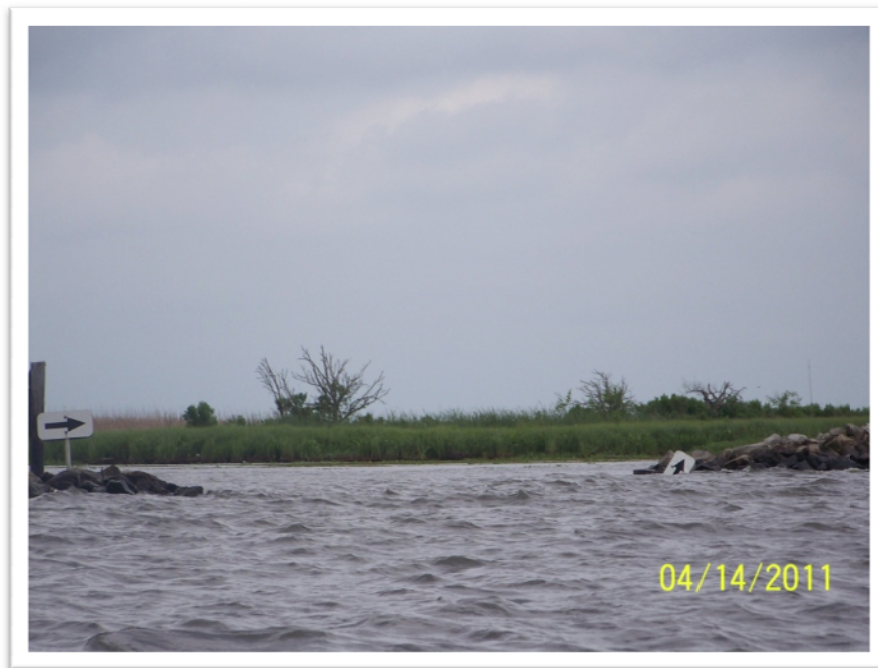
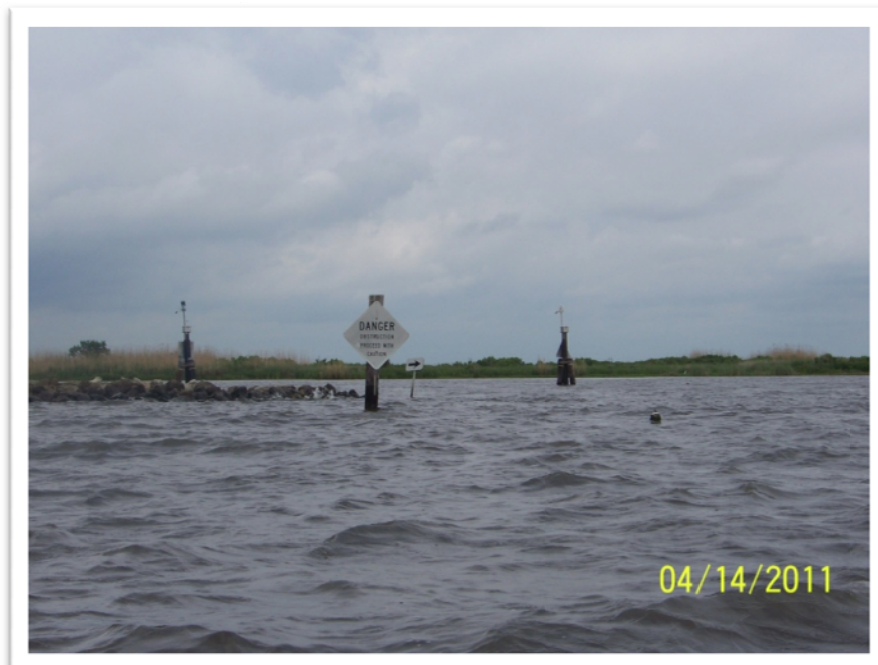
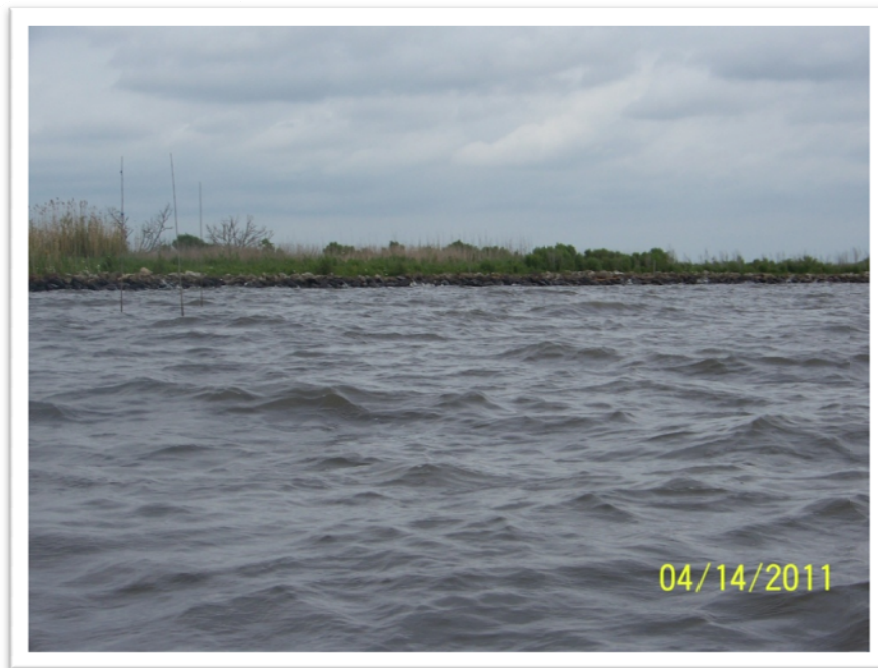
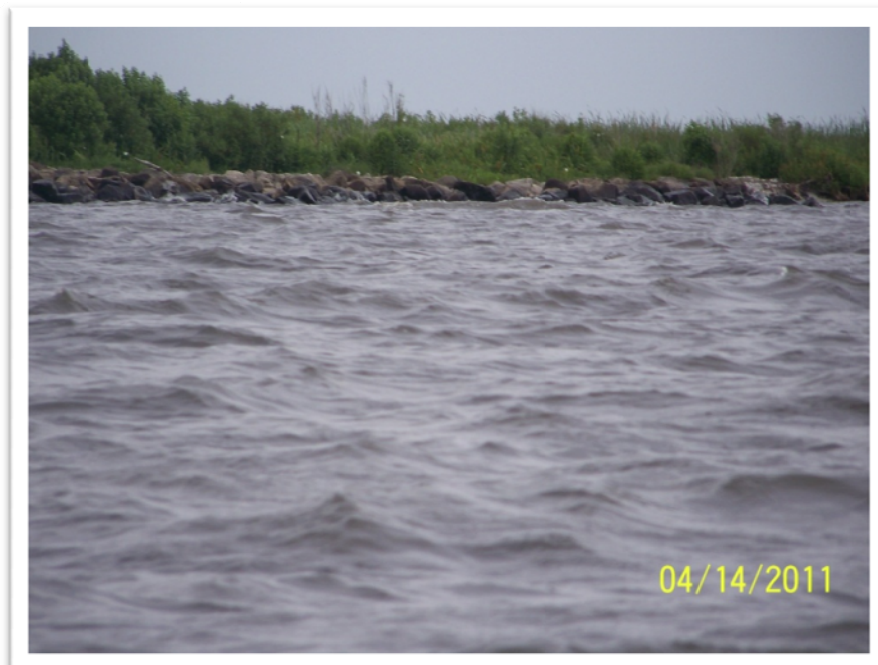
According to the as-built drawings, the crest of the weir was constructed to a height of +4.0' NAVD and the scour pad at the bottom of the barge bay was constructed to a height of -6.5' NAVD. It is estimated the rock material settlement at the crest of the weir is minimal, less than 1.0' on both sides of the barge bay. The most severe settlement and scour is near the bottom of the barge bay where previous survey data indicated bottom depths ranged between -6.5' and -15.0'. Based on the severity of the washout of the scour pad beneath the barge bay, the scour pad will be reconstructed in the 2010 Maintenance Project. The method of repair is

outlined in the conclusion of this report. The timber sub-structures supporting the navigational aids are in poor condition; there are cracks and surface damage visible on the timber pile dolphins and one of the navigational arrow signs is down. The timber pile dolphin on the southeast side of the barge bay was replaced in 2006 and remains in good condition. (Appendix B, Photos No. 39 through No. 44)

Structure No.14A was in fair to good condition with significant damage to the timber cluster piles supporting the navigational aids and severe settlement and scour of the rock pad below the barge bay opening. We believe that the strong currents moving through the barge bay opening may be responsible for the excessive scour of the rock pad beneath the barge bay. To reduce the scour, we have included provisions in the 2010 Maintenance Project for the existing scour pad to be replaced with a larger stone. We will also be replacing three (3) of the four (4) timber pile clusters supports for the navigational aid lights as well.

Photo 39: Structure 14A fixed crest rock weir south tie-in to bank, looking west

Photo 40: Structure 14A fixed crest rock weir with barge bay, looking west

Photo 41: Structure 14A fixed crest rock weir with barge bay, looking west

Photo 42: Structure 14A and timber warning signs fixed crest rock weir with barge bay, looking west

Photo 43: Structure 14A fixed crest rock weir with barge bay, looking west

Photo 44: Structure 14A fixed crest rock weir north tie-in to bank, looking west
